GEOTECHNICAL INVESTIGATION

**NASH MILL ROAD ASSOCIATION
LANDSLIDE EVALUATION AND REPAIR
NASH MILL ROAD
PHILO, CALIFORNIA**

Project Number 13658.01

August 22, 2024

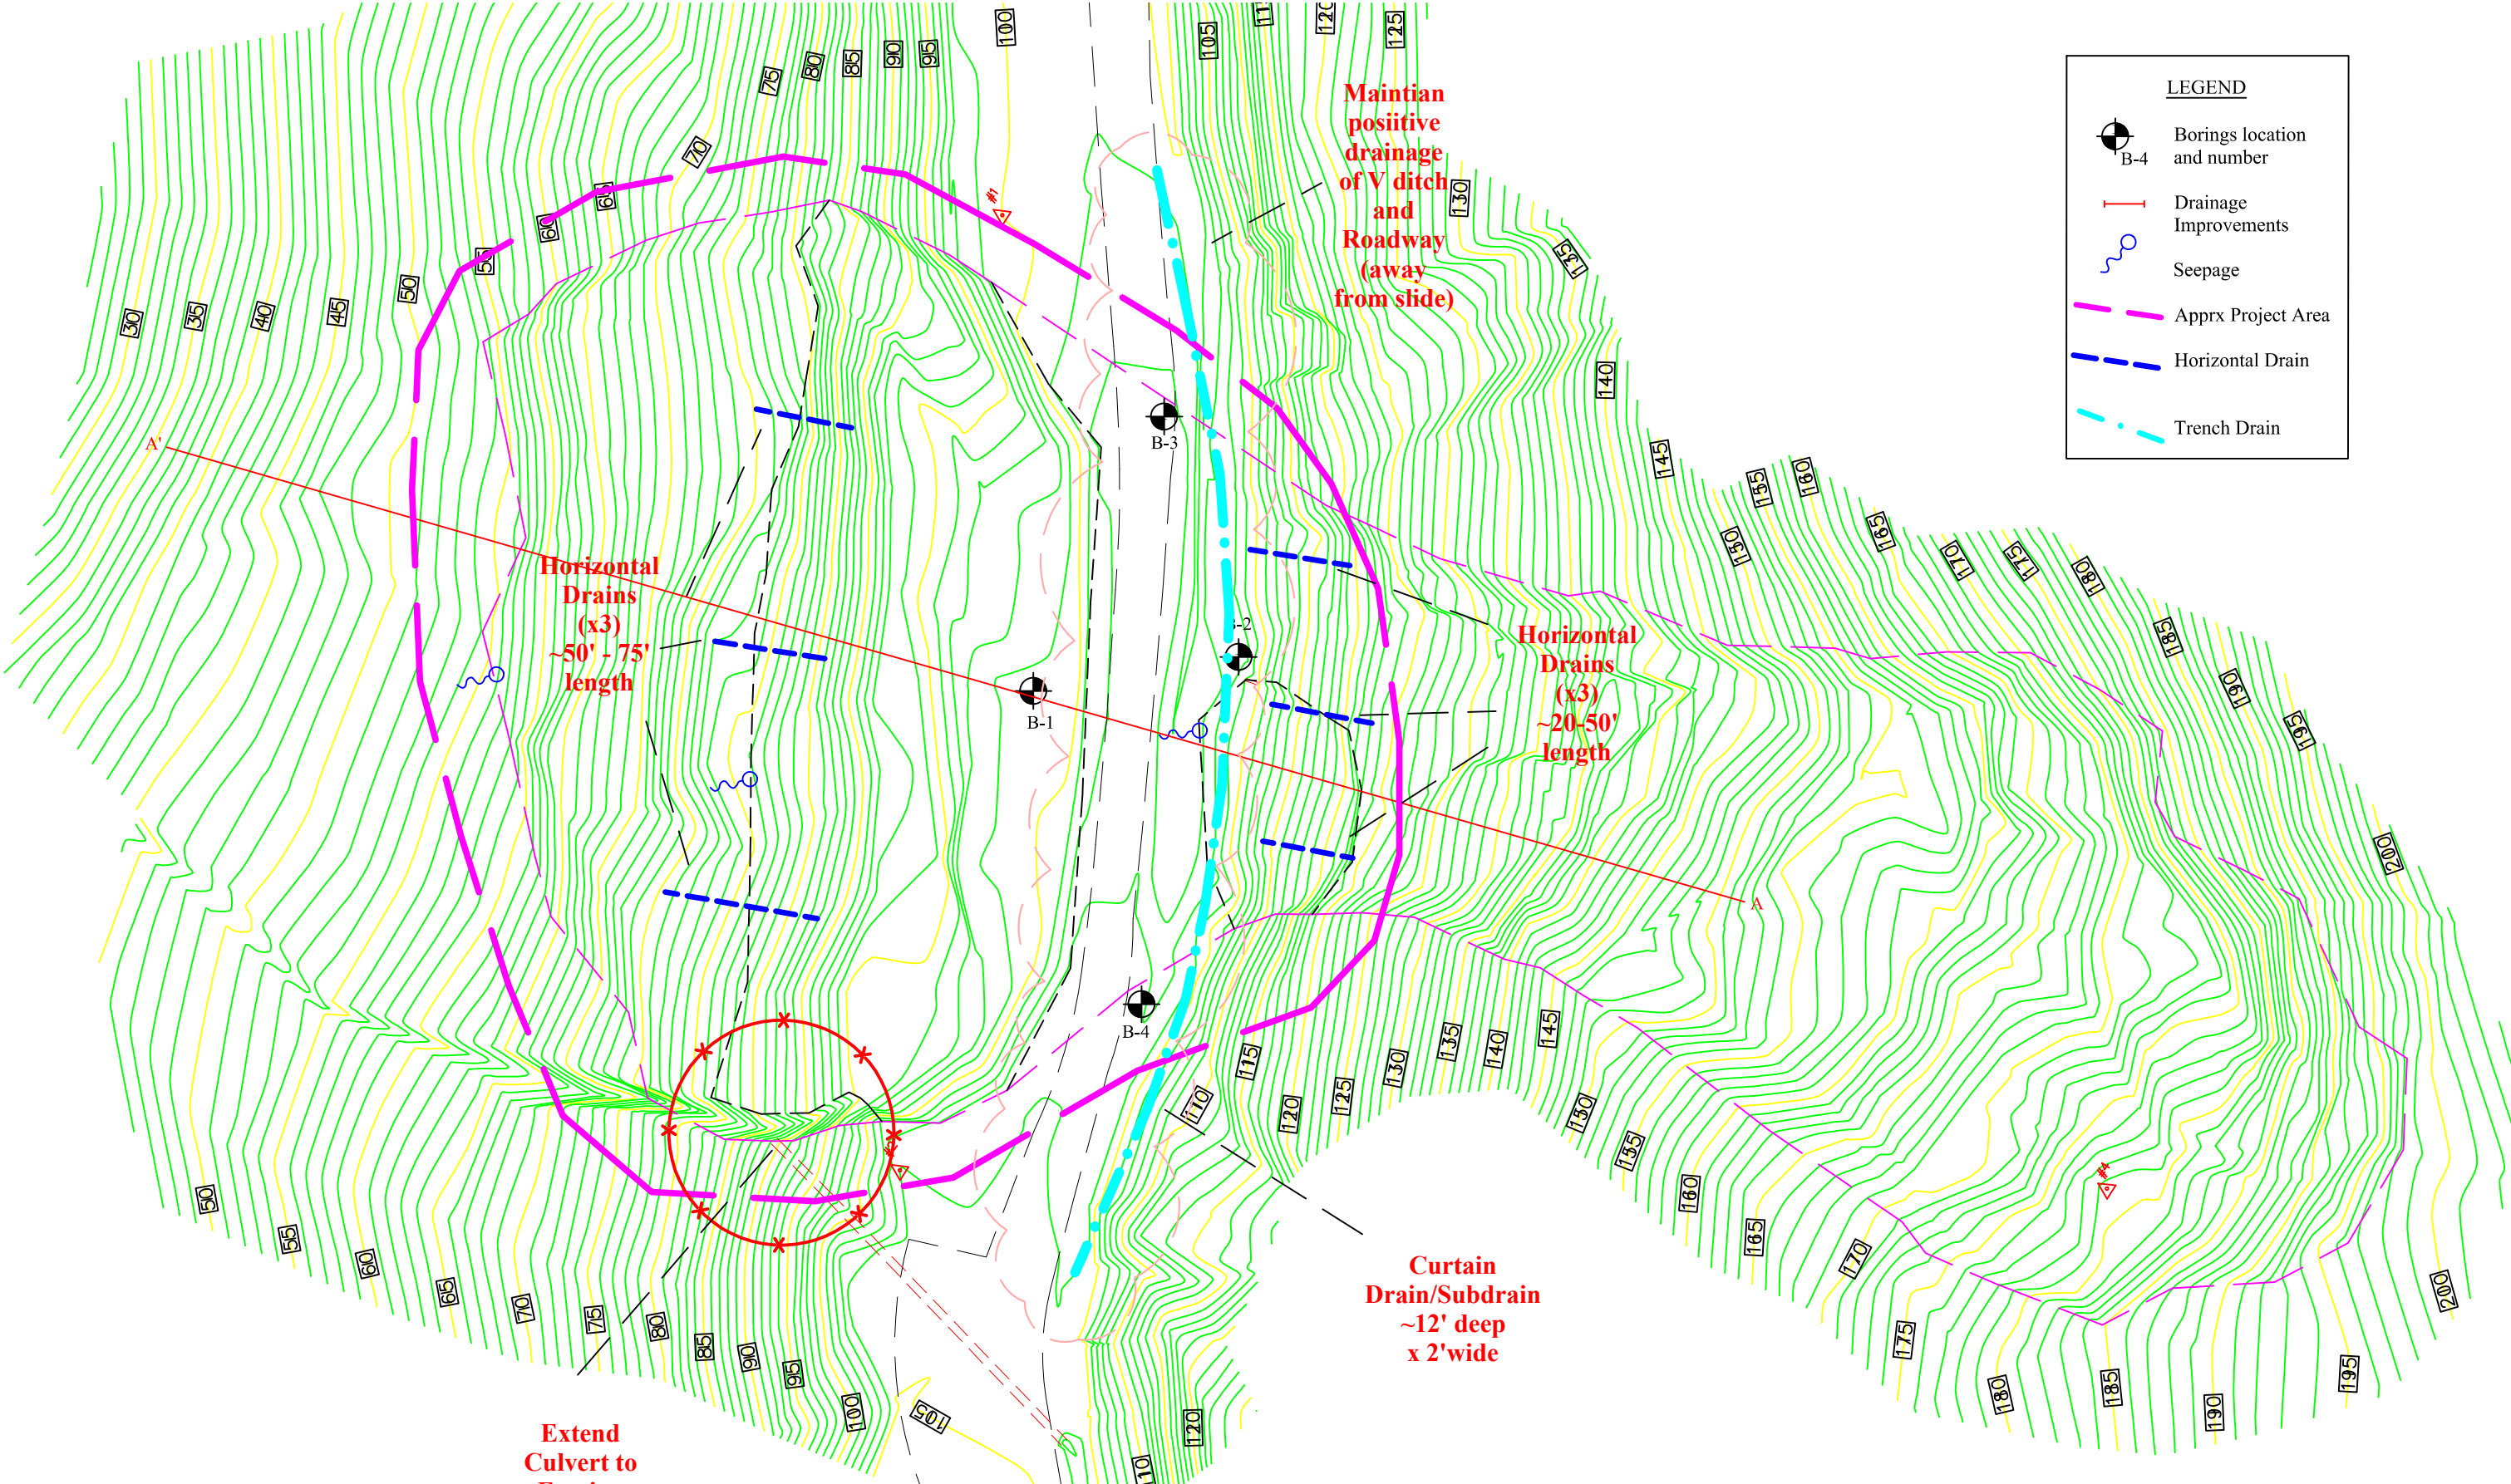
An inboard earthen drainage ditch was observed upslope of Nash Mill Road. Part of the water in this drainage ditch is being captured by an 18-inch corrugated polycarbonate culvert which crossed Nash Mill Road near the western extent of the instability. This culvert discharges approximately 35 feet downslope of Nash Mill Road along the western perimeter of the area of instability. Both the drainage ditch and the culvert were flowing at the times of our site visits.

Seepage was observed within the unstable area immediately upslope of Nash Mill Road and as well as several locations withing the unstable area downslope of Nash Mill Road. Groundwater was encountered in all of the exploratory borings at depths ranging from 16.5 to 24.0 feet below the surface.

If site grading is not completed prior to the next rainy season, we recommend that horizontal drains be installed to minimize groundwater intrusion into the area of instability during the wet season. Concurrently a curtain drain should be installed on the upslope side of Nash Mill Road, extending across the project area. The drain should be a minimum of 12 inches wide and extend through the near surface materials and a minimum of 1 foot into bedrock. The depth of the subdrain should be determined by a representative of BAI in the field at the time of construction, however, for planning purposes, depths of 10 feet should be anticipated. Class 2 permeable material should be used in lieu of ¾-inch crushed rock to eliminate the need for filter fabric. The subdrain should be constructed according to the general detail provided on Plate 13. General horizontal and curtain drain locations have been indicated on the Site Map, Plate 2.

Surface drainage should be by sheet flow directed to erosion resistant areas away from the project site. We recommend an earthen drainage ditch be constructed at the upper extent of the project site to intercept surface water and direct it away from the area of repair.

We noted an existing earthen drainage ditch on the inboard side of the project site. This should be maintained and sloped to drain by gravity away from the area of repair. A culvert was observed west of the project site which appears to have been designed to capture the water in the drainage ditch and move it across and downslope of Nash Mill Road. The culvert consists of an 18-inch diameter polycarbonate pipe which discharges approximately 35 feet north and downslope of Nash Mill Road. The culvert discharges into an erosional gully located near the toe of the area of current instability. This culvert should be redirected downslope and away from the area of instability and discharged to existing drainage courses or erosion resistant area. The erosional gully should be repaired by grading according to the specifications of this report to match the adjacent slopes and be designed to drain by sheet flow away from the project area.

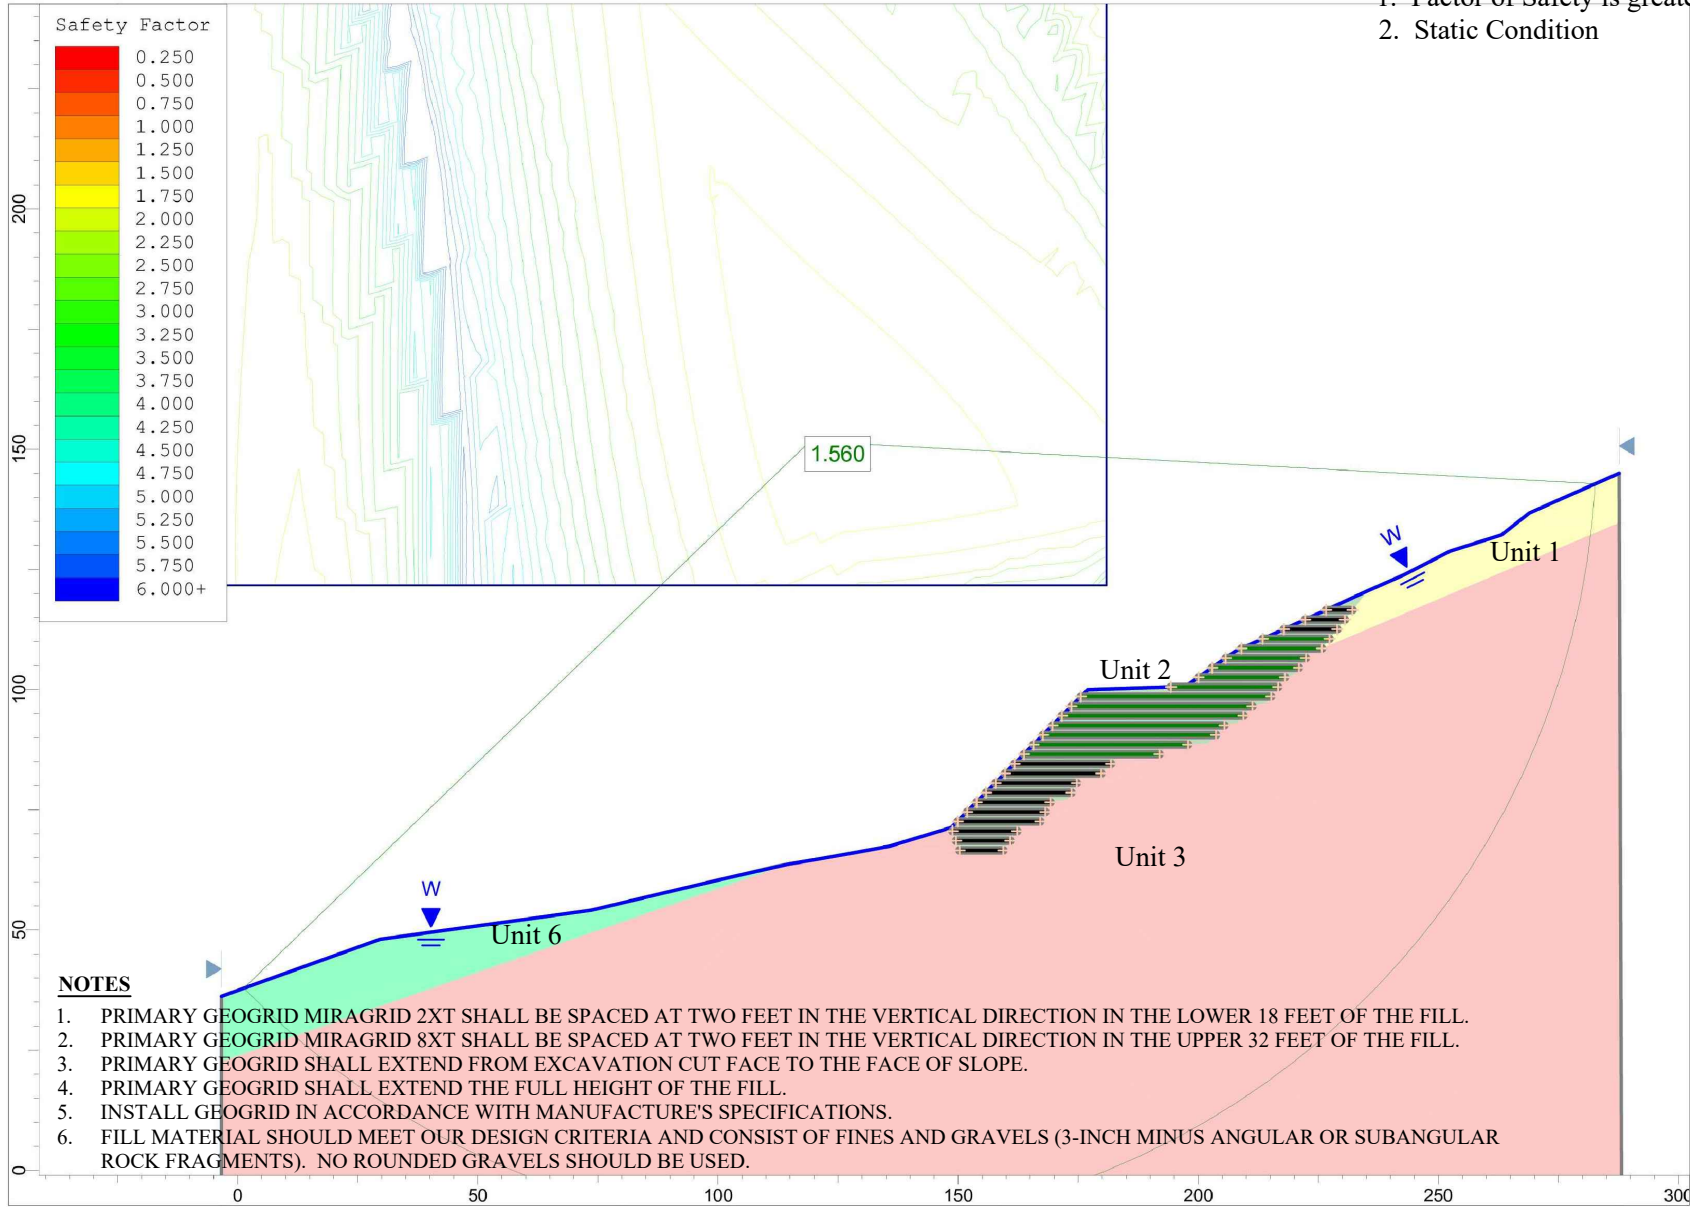
The results of our stability analyses show that the slope and road repaired as a compacted engineered fill reinforced with geogrid is stable for both static and seismic conditions, if the recommendations presented below are followed. The results of our stability analyses are presented in Appendix C.

Notes:
 1. Factor of Safety is greater than 1.5
 2. Static Condition

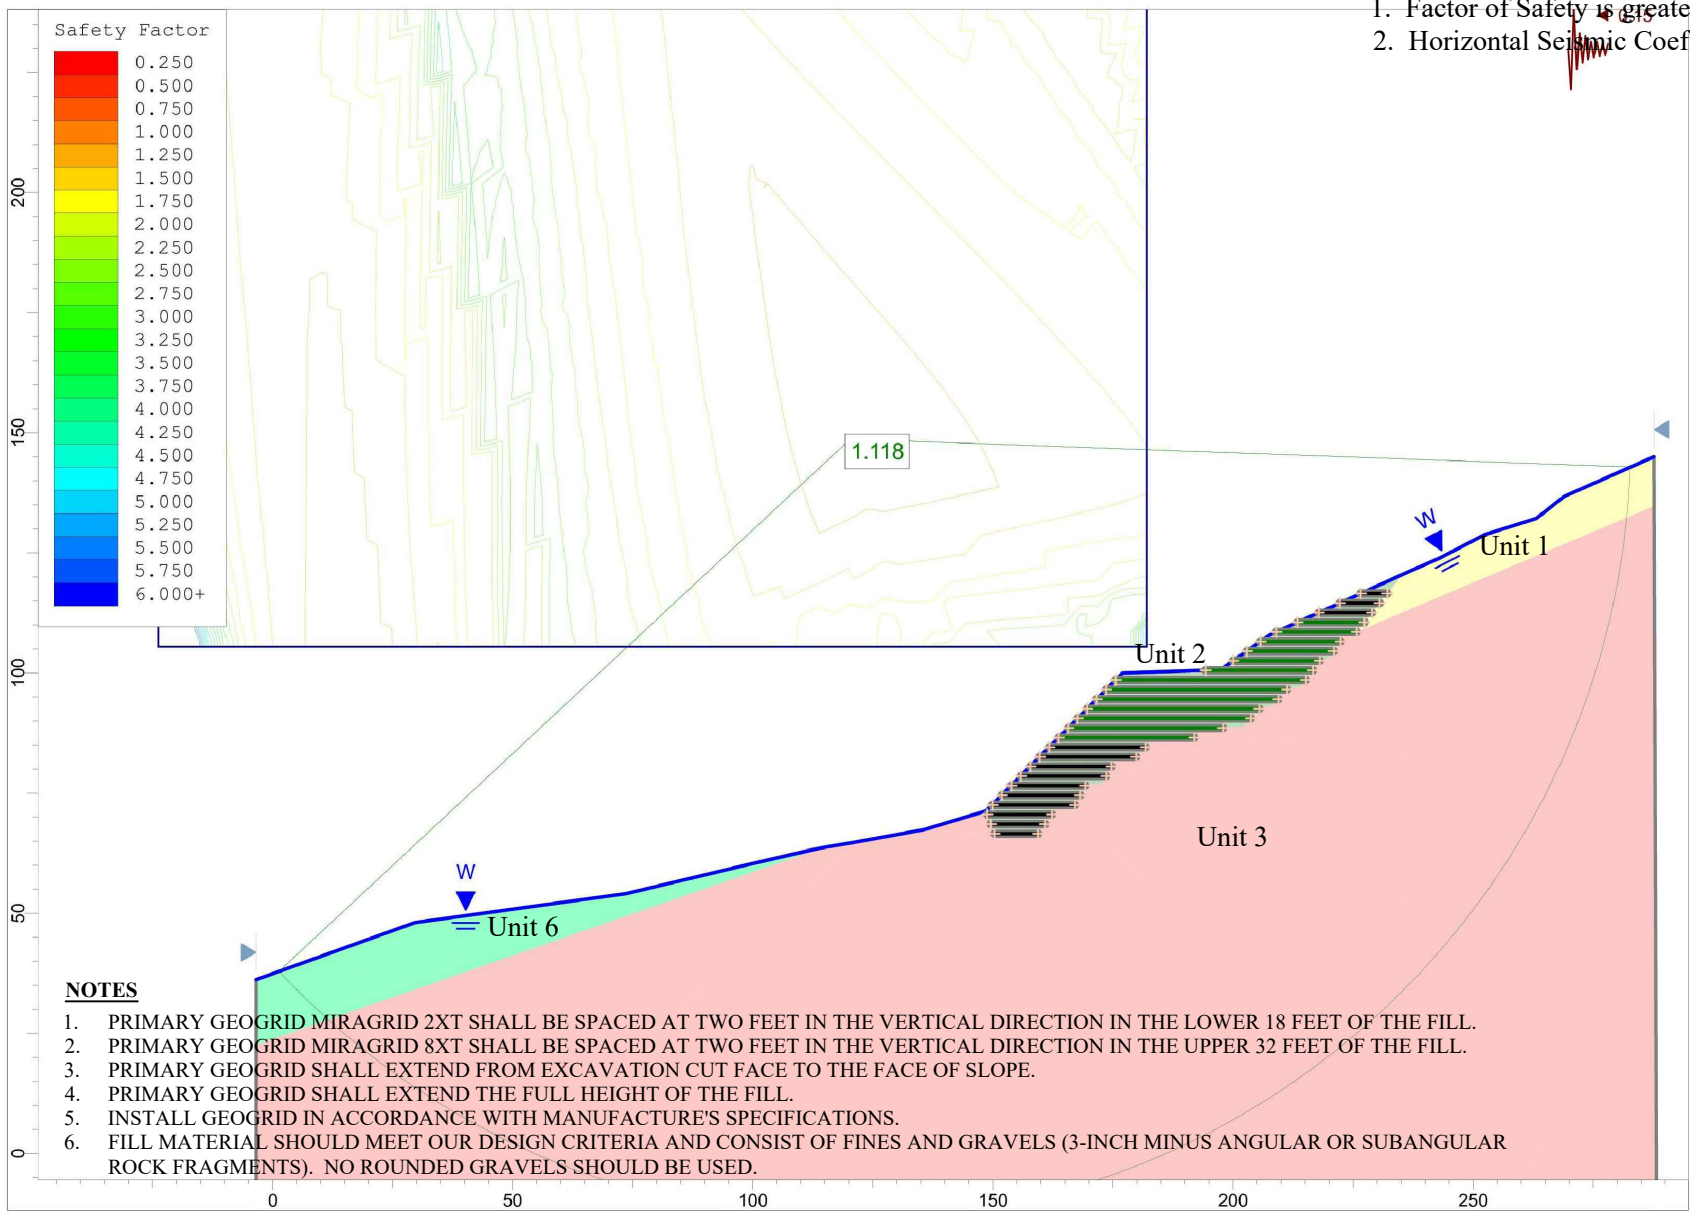
Notes:
1. Factor of Safety is greater than 1.1
2. Horizontal Seismic Coefficient 0.15
