STREAM INVENTORY REPORT

Mill Creek

A stream inventory was conducted from October 14 to October 22, 2013 on Mill Creek. The survey began at the confluence with Navarro River and extended upstream 6.8 miles.

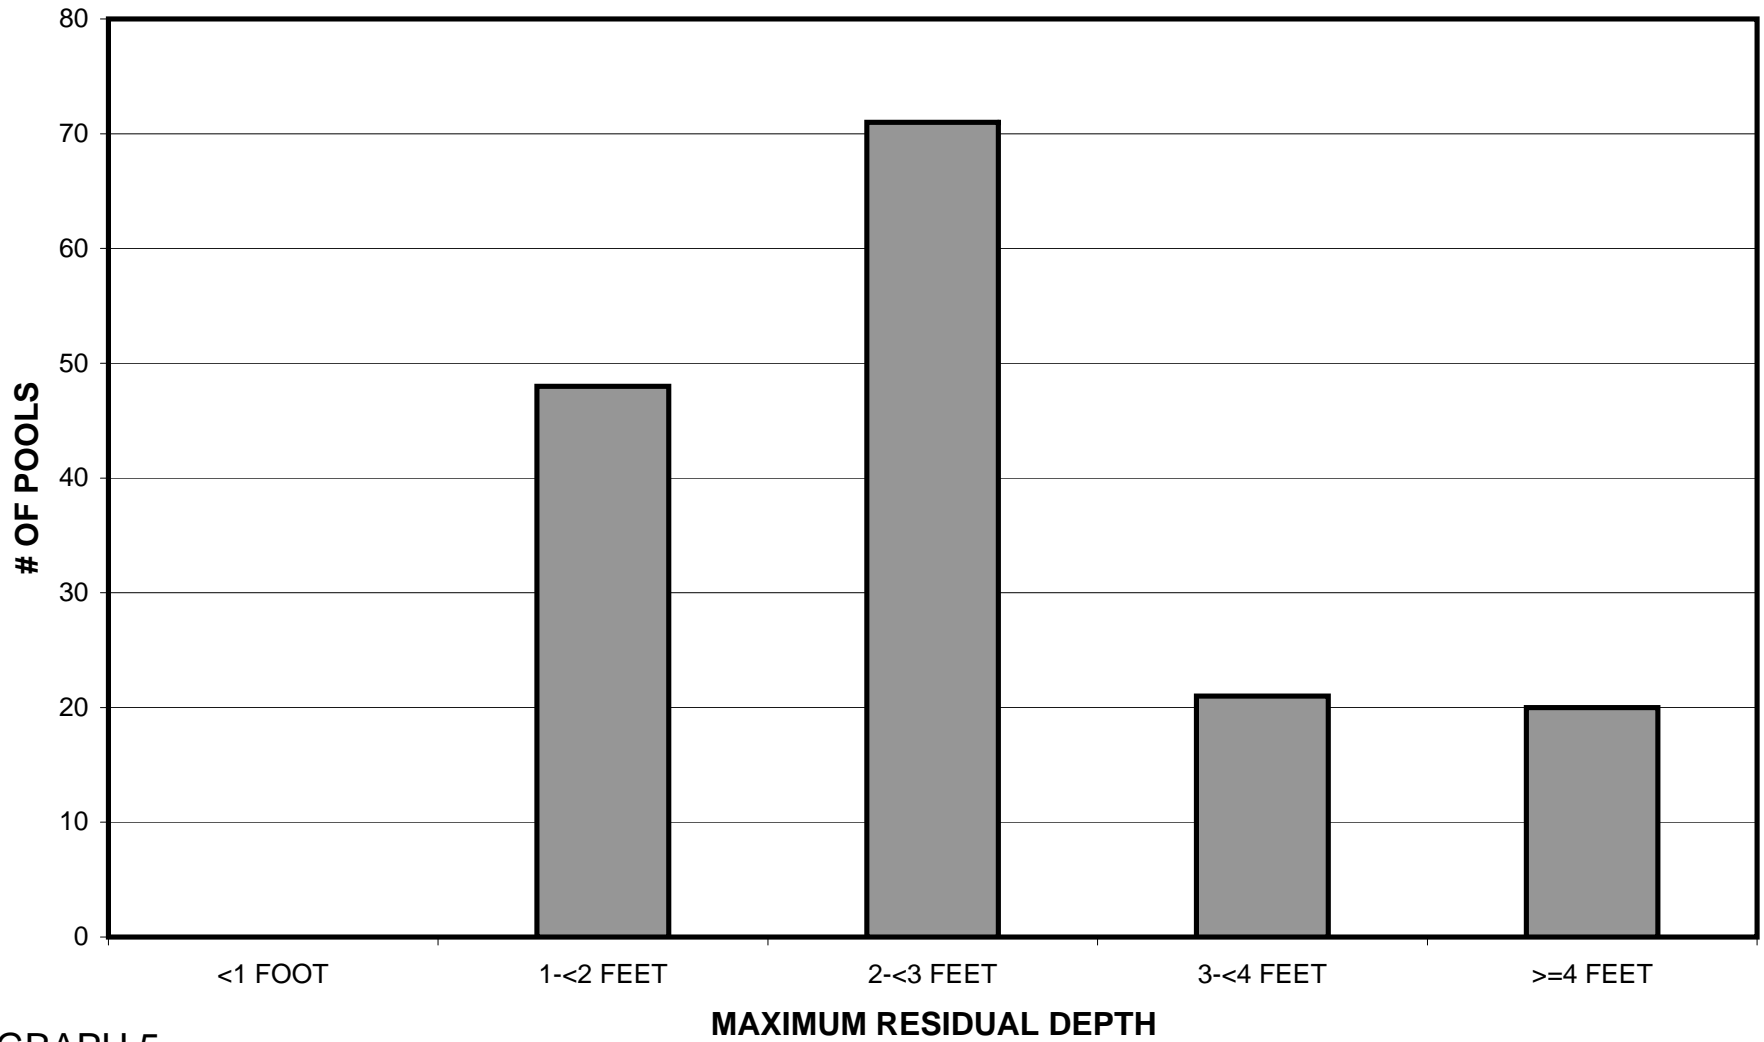
GRAPH 5

Table 4 is a summary of maximum residual pool depths by pool habitat types. Pool quality for salmonids increases with depth. One hundred twelve of the 160 pools (70%) had a residual depth of two feet or greater (Graph 5).

Flatwater habitat types comprised 52% of the total length of this survey, riffles 15%, and pools 31%. One hundred twelve of the 160 (70%) pools had a maximum residual depth greater than two feet. In general, pool enhancement projects are considered when primary pools comprise less than 40% of the length of total stream habitat. In first and second order streams, a primary pool is defined to have a maximum residual depth of at least two feet, occupy at least half the width of the low flow channel, and be as long as the low flow channel width. Installing structures that will increase or deepen pool habitat is recommended.

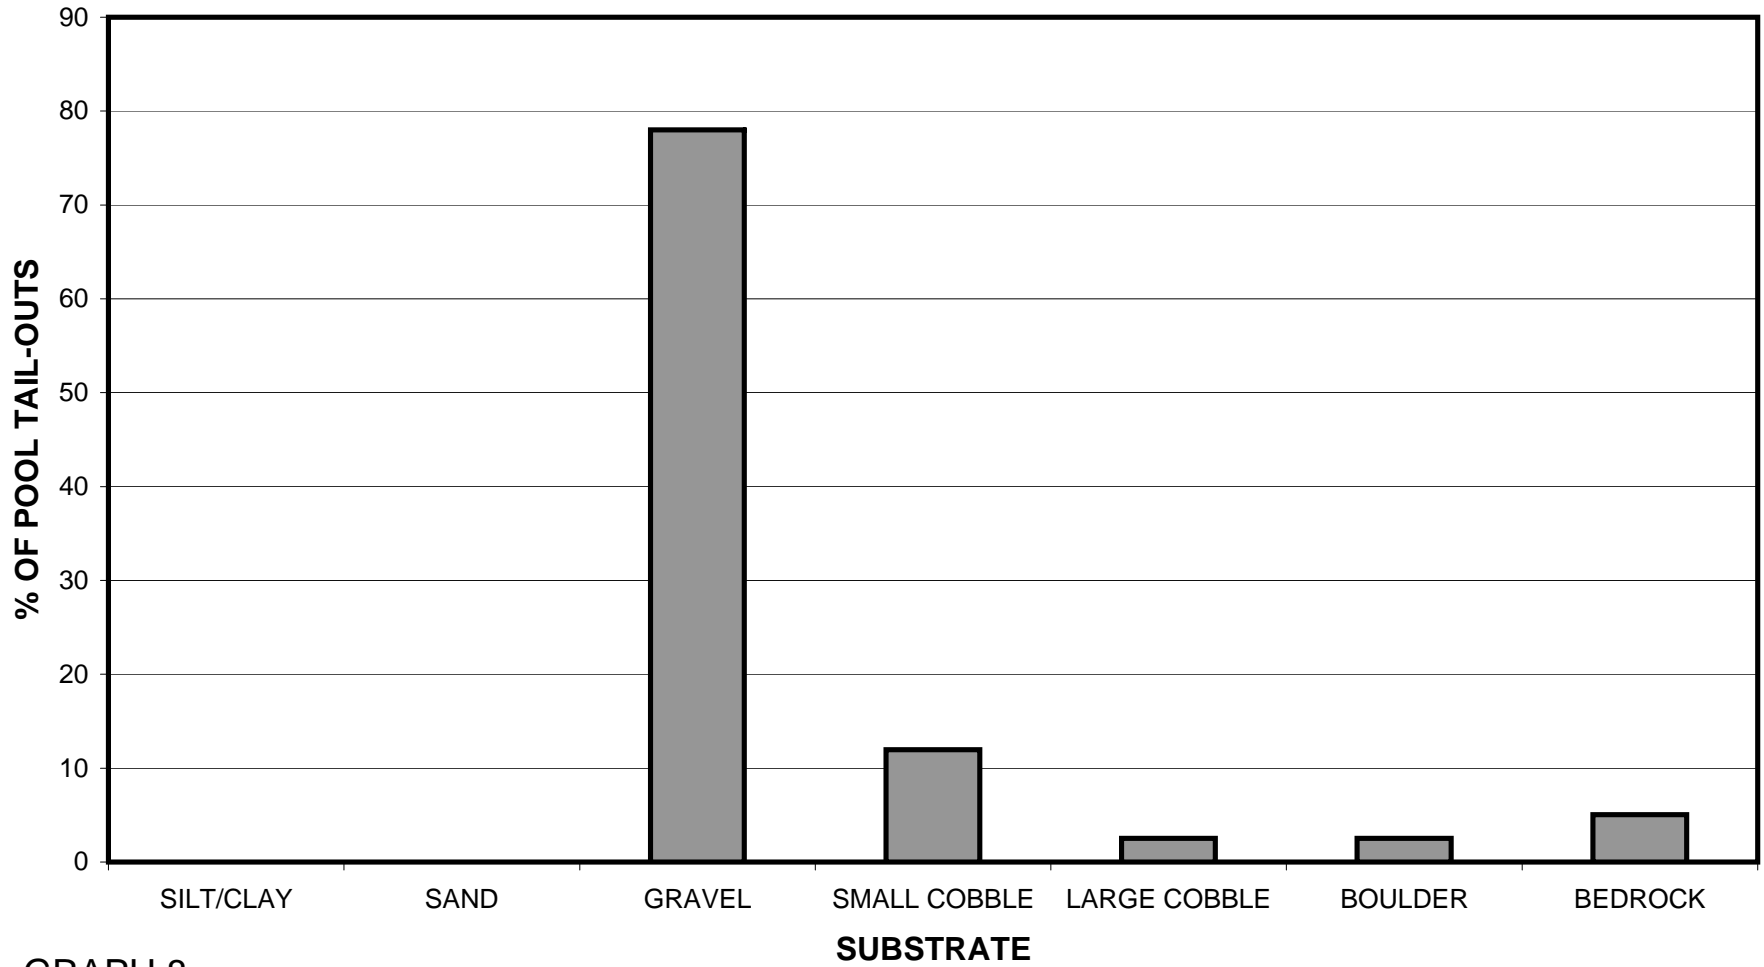
GRAPH 8

Table 6 summarizes the dominant substrate by habitat type. Graph 8 depicts the dominant substrate observed in pool tail-outs. Gravel was the dominant substrate observed in 78% of the pool tail-outs. Small cobble was the next most frequently observed dominant substrate type and occurred in 12% of the pool tail-outs.

One hundred forty-four of the 160 pool tail-outs measured had gravel or small cobble as the dominant substrate. This is generally considered good for spawning salmonids.

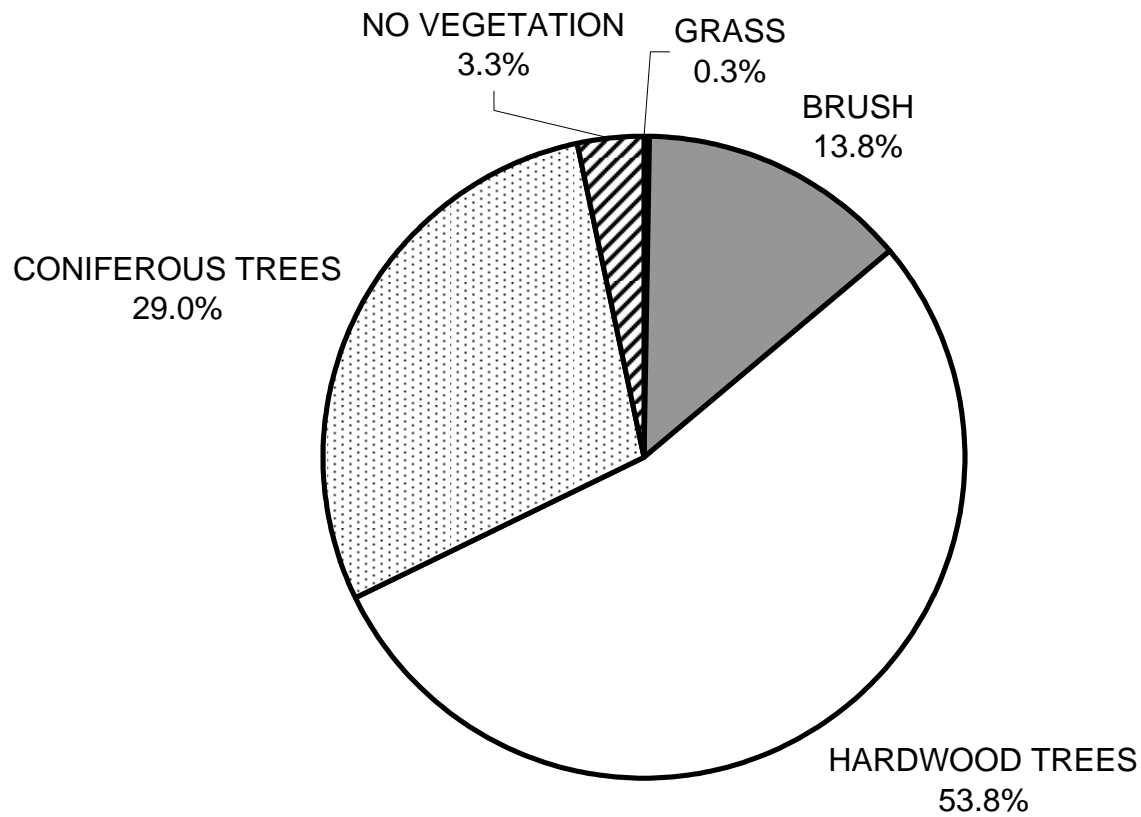
GRAPH 11

For the stream reach surveyed, the mean percent right bank vegetated was 97%. The mean percent left bank vegetated was 96%. The dominant elements composing the structure of the stream banks consisted of 57% sand/silt/clay, 24% bedrock, 15% cobble/gravel, and 4% boulder (Graph 10). Hardwood trees were the dominant vegetation type observed in 54% of the units surveyed. Additionally, 29% of the units surveyed had coniferous trees as the dominant vegetation type, and 14% had brush as the dominant vegetation type (Graph 11).
