Date: August 11, 2015

From: Colin Hughes, PG# 8549
Pacific Watershed Associates
PO Box 4433
Arcata, CA 95518

Design Basis and Plan Description Memorandum for the Martinez Crossing Design, Mendocino County, California.

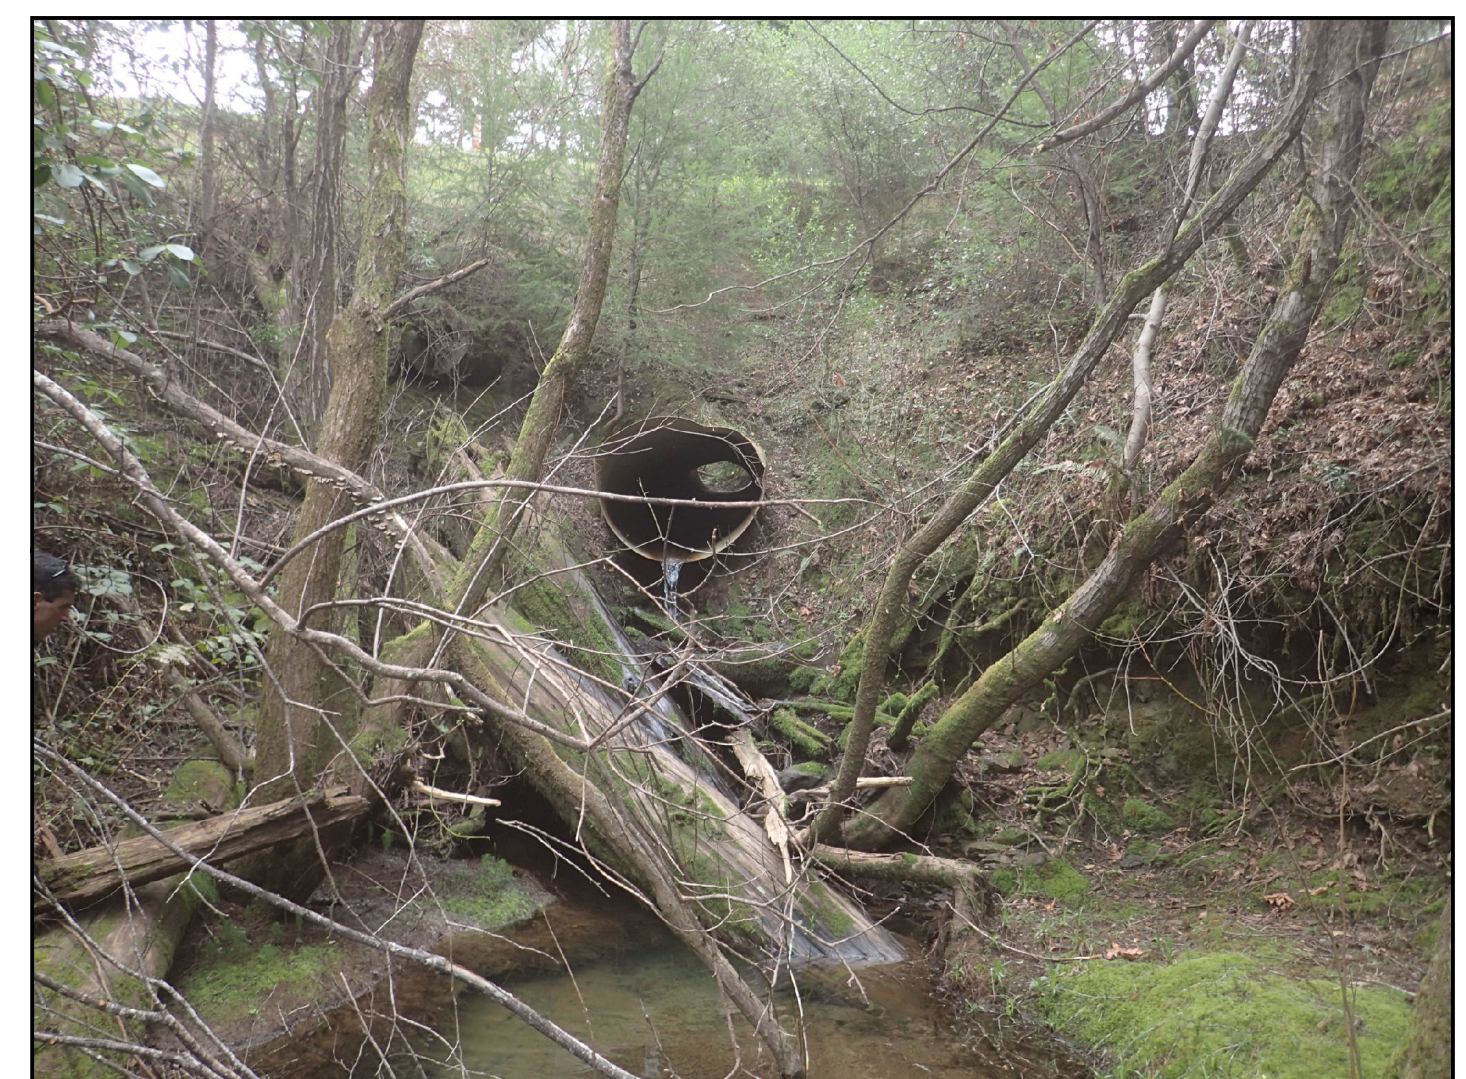
Photo 1. View looking upstream at the outboard fillslope and culvert.

The stream crossing at the site was first installed in the 1950s or earlier, and was observed to be in-place on historical aerial photographs taken in 1952. The crossing flow conveyance structure has likely been replaced at least once since its original installation. The existing culvert has been installed with both the inlet and outlet set high in the fill and with the inlet skewed to the east of the historic channel alignment to allow for a shorter length of culvert to be installed perpendicular to the roadway

(Figure 1, Photo 1). Woody debris can be seen to be emplaced within the earthen crossing fill from the downstream side where the outboard fillslope has been partly washed away from splash zone erosion at the culvert outlet. The culvert is observed to be deformed from vertical pressures and is partially squashed, reducing the hydraulic capacity of the culvert (Figure 1, Photo 2). The culvert inlet was measured to be 66 inches in width and 50 inches in height. Based on observable deformation in the middle of the culvert from the interior, it is interpreted that the outboard half of the culverted fill likely slumped in the past during a period of saturation or leakage and partially sheared the culvert, separating some of the culvert plating. This sheared section of culvert was later repaired by local landowners by patching with cast-in-place concrete. Repairs by addition of cast-in-place concrete around the culvert inlet at the inboard fill face were also observed and were likely required due to surface water infiltrating the stream crossing fill via soil piping, preferential stream flowpaths developed through erosion of the crossing fill and/or decomposition of organic materials.

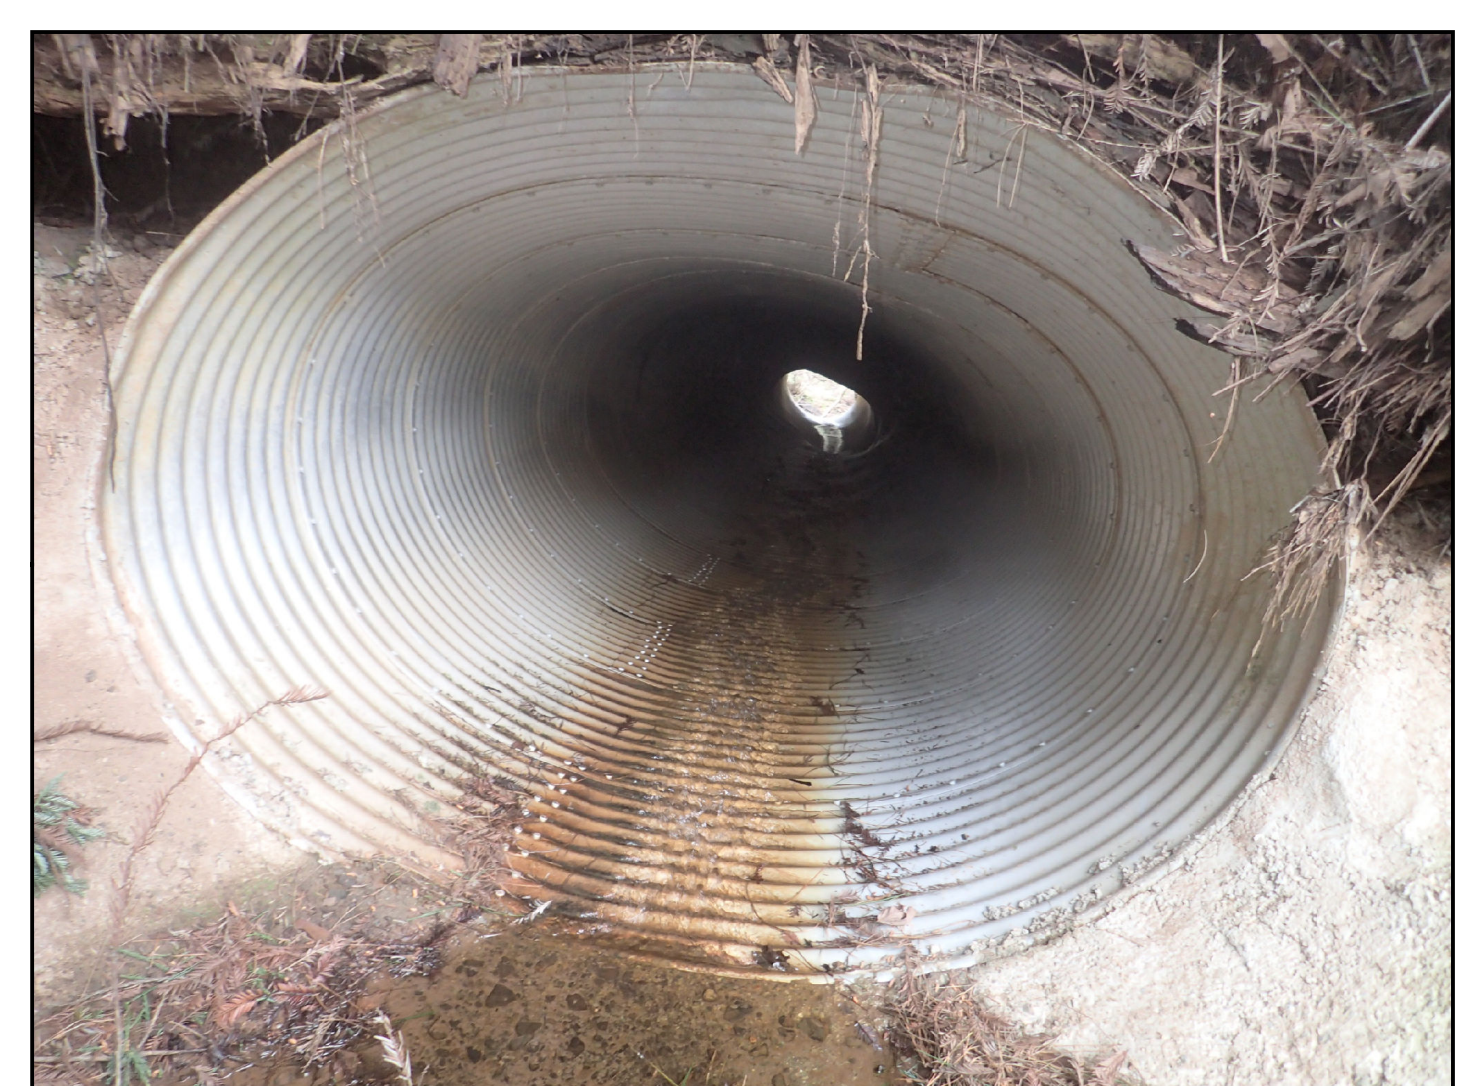
Photo 2. View of the culvert inlet. Note the deformation of the culvert and concrete used to repair the inboard fill face.
