GEOTECHNICAL INVESTIGATION

**NASH MILL ROAD ASSOCIATION
LANDSLIDE EVALUATION AND REPAIR
NASH MILL ROAD
PHILO, CALIFORNIA**

Project Number 13658.01

August 22, 2024

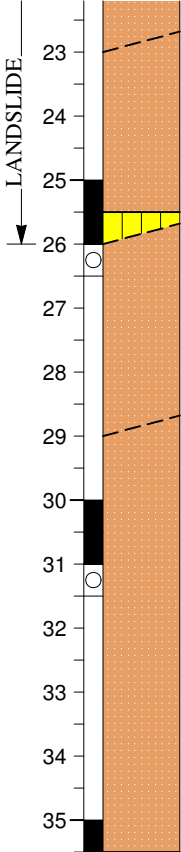
Sampler Type*	Moisture Content (%)	Dry Density (pcf)	Blows/foot	Depth (ft.)	Sample
				23	GRAY-BROWN SHEARED SANDSTONE closely fractured, low hardness, deeply to moderately weathered
				24	
CA		55/11" **		25	OLIVE-BROWN SANDY SILT (ML) hard, saturated ORANGE-BROWN SANDSTONE close fracturing, low hardness, deeply to moderately weathered
				26	
				27	GRAY TO ORANGE SANDSTONE crushed to closely fractured, low hardness to hard, moderately weathered
				28	
				29	
CM		60 **		30	
				31	
				32	
				33	
				34	
CM		47/5" **		35

- Notes:
1. Free water encountered at 17 feet
 2. No caving
 3. Drilling refusal at 35.5 feet

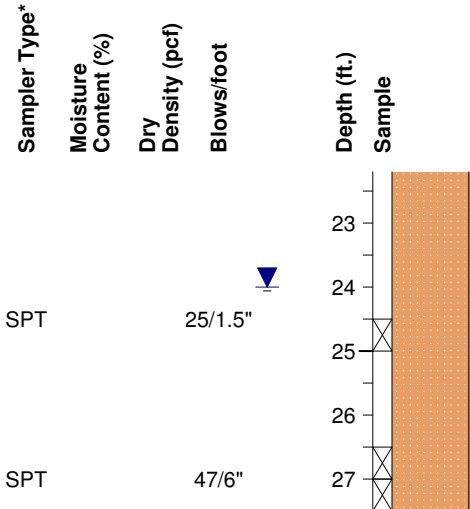
- Notes:
1. Groundwater at 16.5 and 24 feet
 2. No caving
 3. Drilling refusal at 26.5 feet

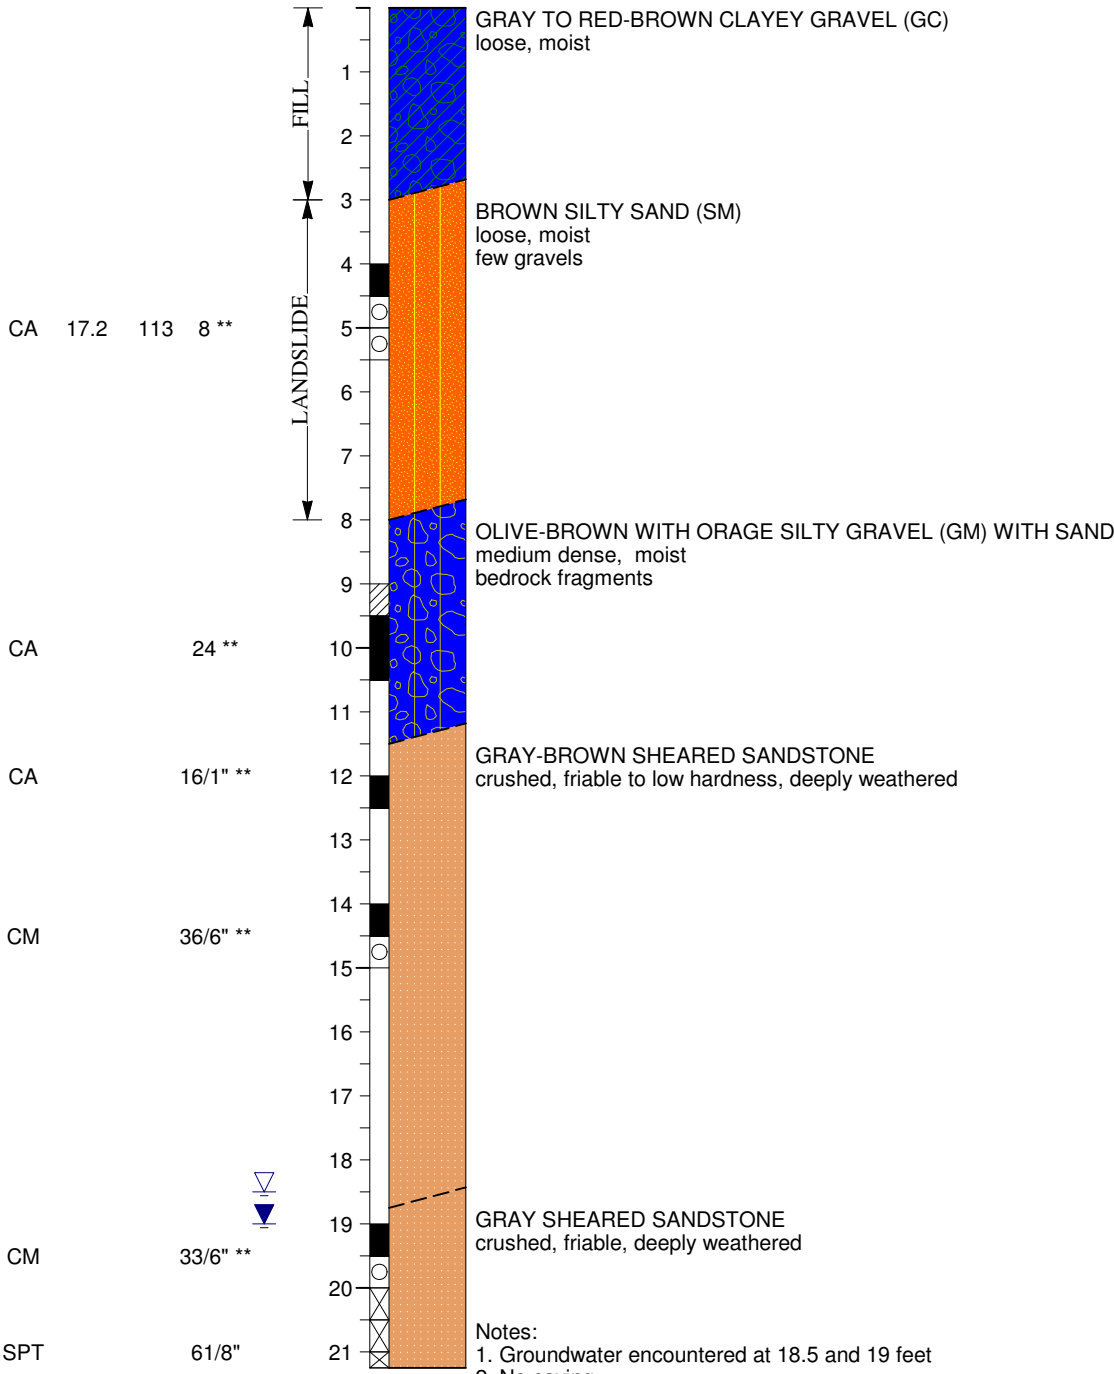
- Notes:
1. Groundwater encountered at 18.5 and 19 feet
2. No caving
3. Drilling terminated at 21.5 feet

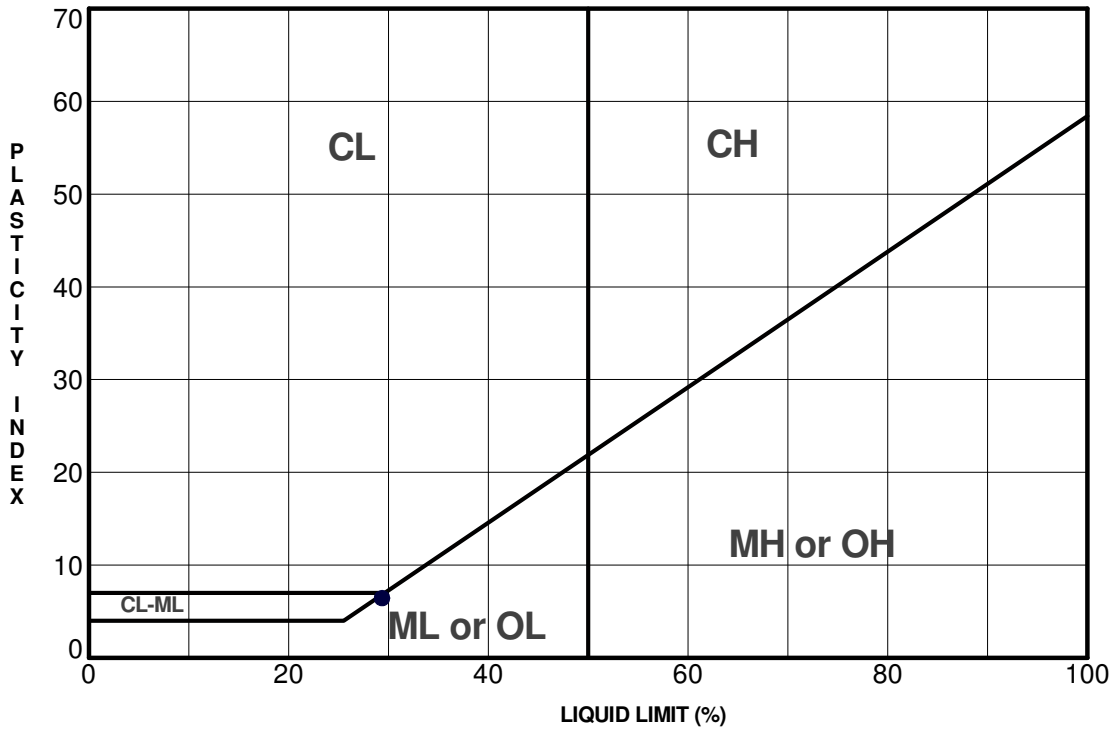
SYMBOL	CLASSIFICATION AND SOURCE	LIQUID LIMIT (%)	PLASTIC LIMIT (%)	PLASTICITY INDEX	% PASSING No. 200 SIEVE
●	RED-BROWN SANDY SILT (ML) B-1 @ 6.0 feet	29	23	6	50

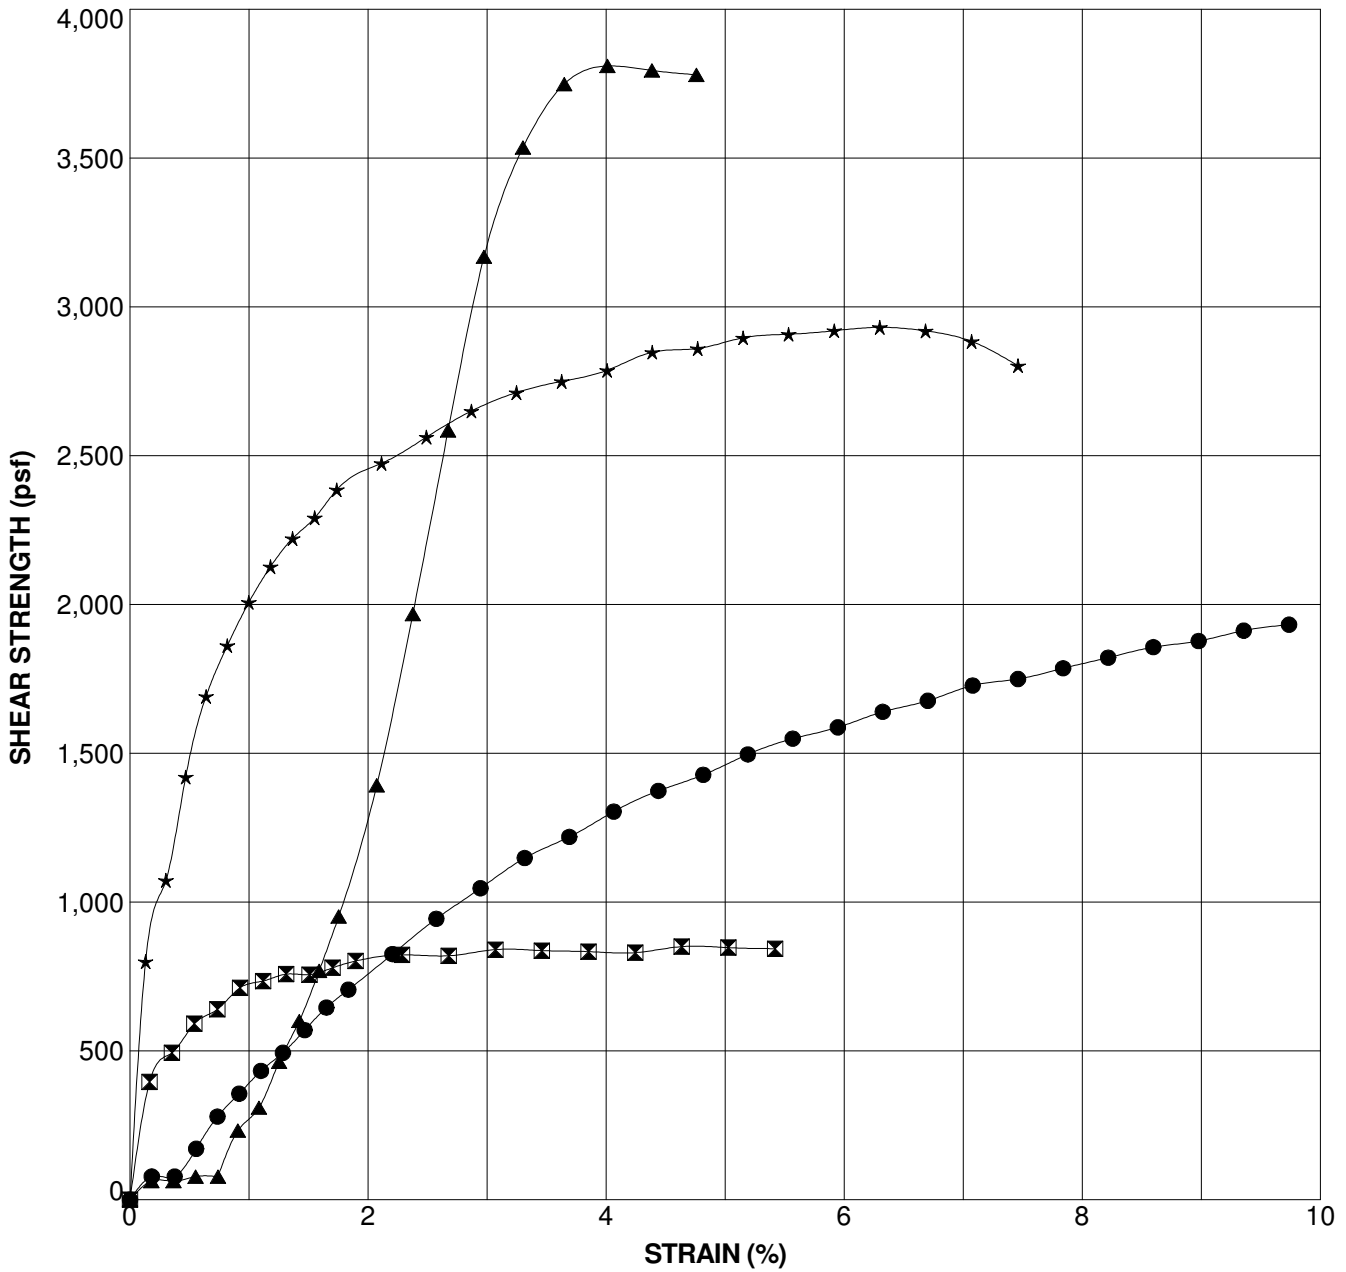
Sample Source	Classification	Confining Pressure (psf)	Ultimate Strength (psf)	Strain (%)	Dry Density (pcf)	Moisture Content (%)
● B-1 at 11 ft	BROWN SILTY SAND (SM)	1296	1932	9.7	109	17.8
☒ B-2 at 6.5 ft	LIGHT OLIVE-BROWN MOTTLED GRAY SILTY SAND (SM)	864	850	4.6	90	28.0
▲ B-2 at 10.5 ft	ORANGE TO OLIVE-BROWN SANDSTONE	1440	3809	4.0	120	10.7
★ B-2 at 15.5 ft	GRAY-BROWN SHEARED SANDSTONE	1872	2931	6.3	115	13.5

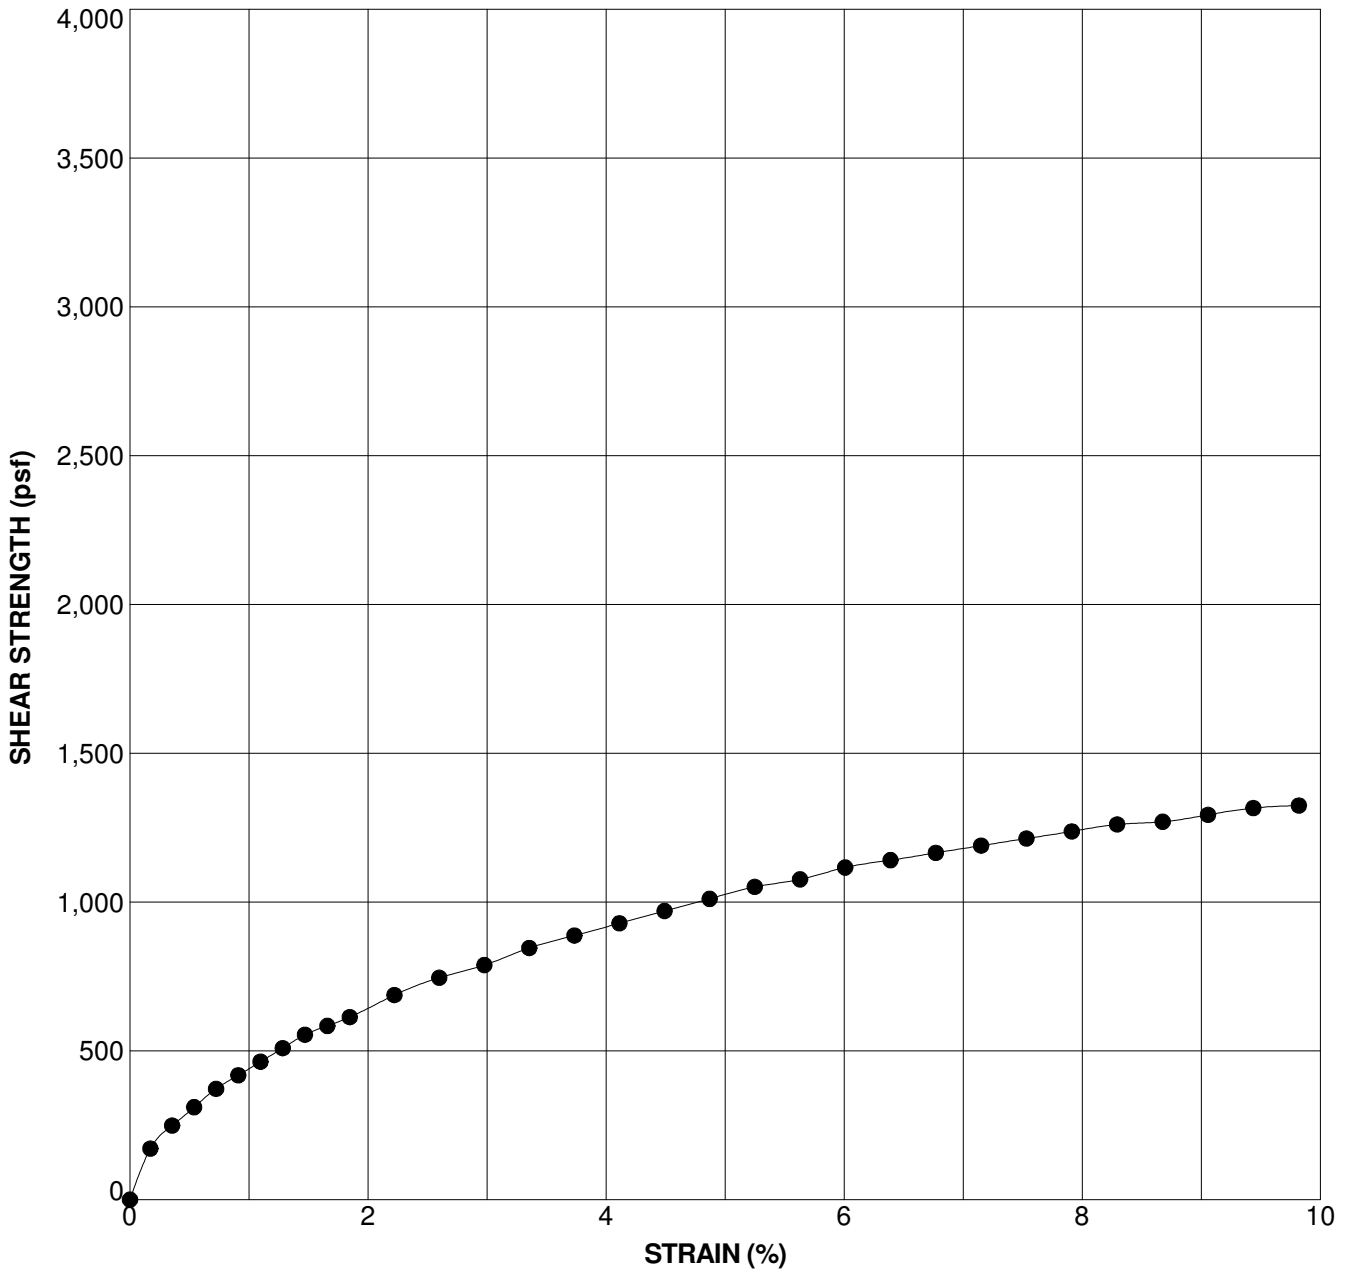
Sample Source	Classification	Confining Pressure (psf)	Ultimate Strength (psf)	Strain (%)	Dry Density (pcf)	Moisture Content (%)
● B-3 at 5 ft	BROWN SILTY SAND (SM)	720	1324	9.8	113	17.2
