# Update on the Martinez Crossing

Prepared by François Christen and Pacific Watershed Associates

August 2015

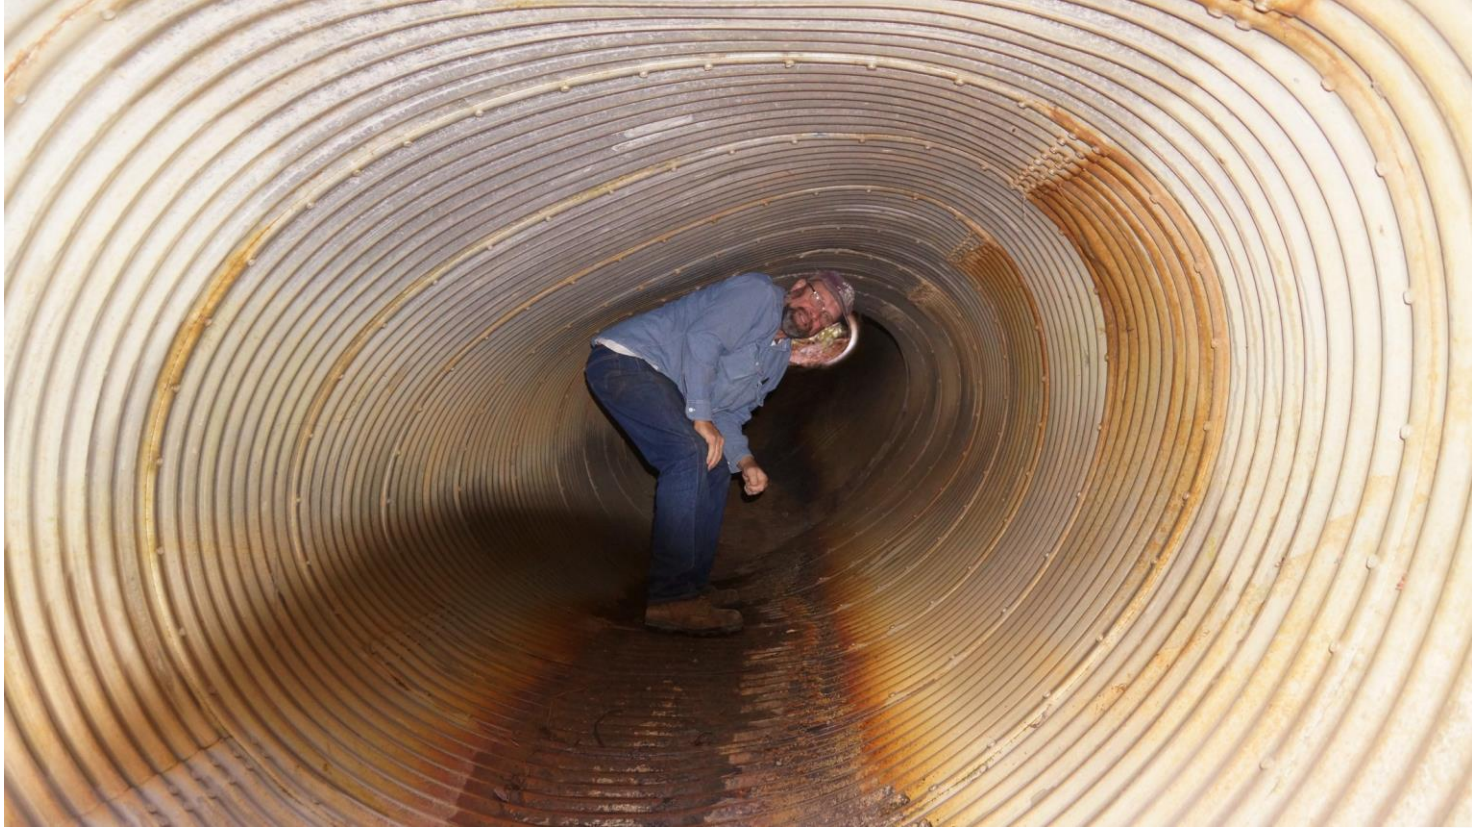
# The Partially Collapsed Culvert

- The culvert is undersized by modern standards
  - Caltrans and other road building agencies install culverts today that can withstand large storms that occur roughly every 100 years,
  - Our consultants, Pacific Watershed Associates, calculate that we would need a culvert that is eight (8) feet in diameter to handle the water that might run off in a 100-year storm,
  - The existing culvert at the Martinez crossing is only four (4) feet in diameter,
    - A four-foot culvert has an area of 12.6 square feet while a eight-foot culvert has an area of 50.2 square feet,
    - Therefore a eight-foot culvert has roughly **four** times the area of a four-foot culvert, and can therefore carry four times as much water,
  - Moreover, the existing culvert is partially collapsed; that means that the culvert **CANNOT** handle as much water as an intact four-foot culvert could handle.

- Removal of the existing undersized and damaged culvert and installation of an 8 ft. diameter and 140 ft. long culvert, capable of surviving a 100-year storm,
- This would require excavation of ~875 linear feet of stream channel, installation of a 3,330 cubic yard fill with the 8 ft. diameter corrugated metal pipe (CMP), and storage of approximately 7,000 cubic yards of the removed sediments on the proximal areas of Nash Mill Road,
- Approximately 860 cubic yards of removed sediment may need to be trucked to a nearby property for disposal or placed on Nash Mill Road much further away from the crossing than the bulk of the material.
- Drainage improvements would be made to the road adjacent to the crossing.
